Reppwand - Oselitzenbach Landslide

Ewald Tentschert

Alexander Preh

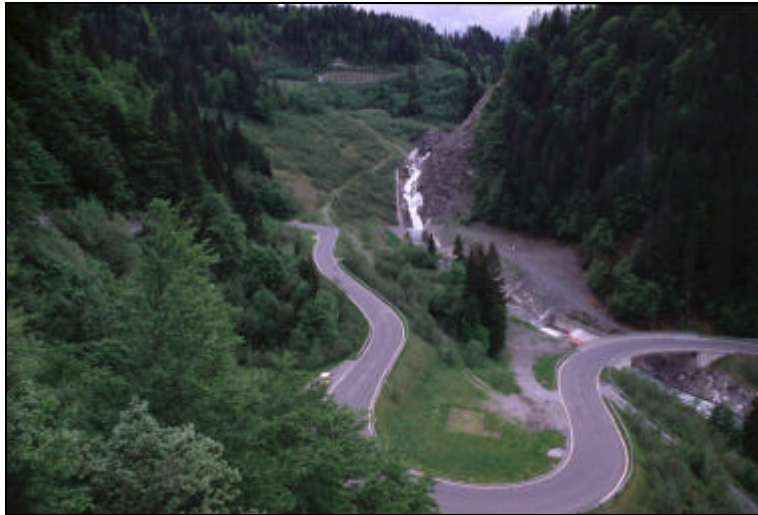
Figure 6: on the left hand side : Reppwand-slide, in the middle: deviated river channel, foreground: Naßfeld road

1988: Realisation of the extensive construction programme. As a part of the construction measures a 400 m long channel was excavated in massive Hochwipfel formations as well as a filling up at the toe was made of the excavated material (about 170.000m³). Additional measures were:

As a consequence to repeated flooding and the resulting advancing undercutting of the eastern toe of the landslide the Oselitzenbach torrent got a new riverbed. Some meters to the north, the 400m long new bed was cut into the massive Hochwipfel formations under the left banks, those preventing the erosion at the sagging toe. A filling up at the toe was made of the excavated material.

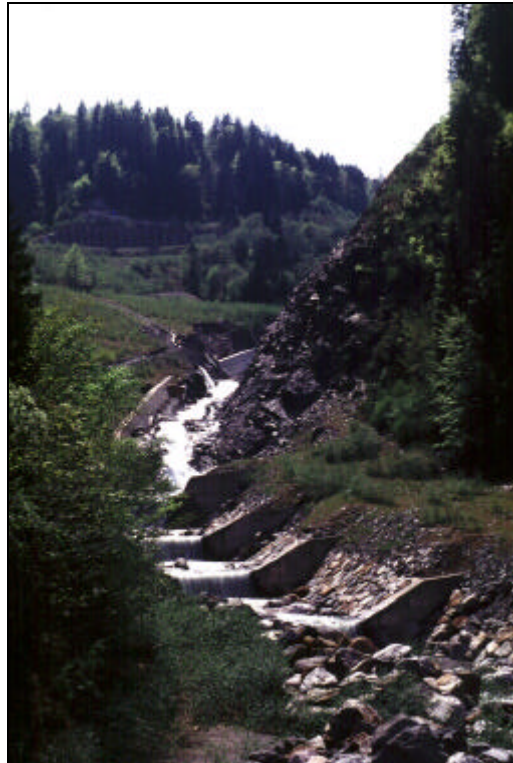
Figure 8: debris barriers and river channel

Torrent barriers in the river to lower the inclination lines of the riverbed, thus reduce erosion processes.
